MINE SITE VISIT REPORT
New Mexico AML Program

Date of Visit : August 22, 2007 **Weather :** Sunny, hot, windy 95°
Mine/Project Name: T- 20 Mine – Northwest of Grants, New Mexico
Duration of Visit : 1.0 hour (11:00 am to 12:00 pm)
Purpose of Visit : Maintenance inspection to the T-20 mine, part of the legacy site assessment for AML project sites.
Observations : Travel to the project site; access to this site was from the west, walking from Haystack Road. Location: T.13N., R.9W., Sec. 30, SE1/4, NW1/4, SE1/4 (1 shaft) Dos Lomas Quad. N3912360 E243020 Uranium Mine. This site is located on BLM land.

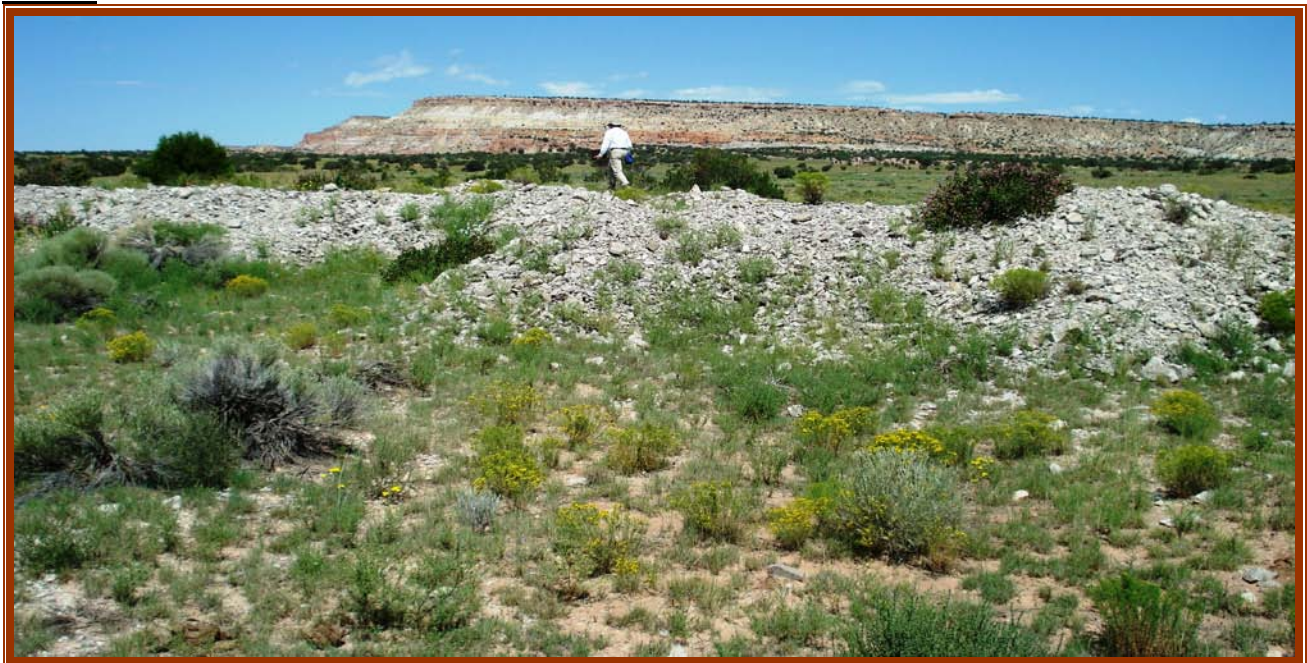
Background radiometric levels of 20 $\mu\text{R/hr}$ at 1-meter and ground level were read utilizing a Ludlum Model-14C survey meter with a NaI Model 44-2 Gamma Scintillator probe and were taken on Haystack Road. The overall waste and ground within the middle portion of the disturbance area have radiometric levels of 100-314 $\mu\text{R/hr}$ at 1-meter and 157-357 $\mu\text{R/hr}$ at ground level. The highest readings, near the shaft opening, were 429 $\mu\text{R/hr}$ at 1-meter and 543 $\mu\text{R/hr}$ at ground level.

This site has areas of mounded waste, some metal mining debris. There is an arroyo along the northeast edge of the site heading southeast towards the main county road. For complete details see topographic GPS info using the MapGuide map found at http://164.64.103.6/mmdtest/AML_Uranium-DEV.htm

Waste Piles Looking Northwest

Further action recommended to mitigate radiometric levels. The only safety concern at this time is the subsided shaft that needs to be backfilled.

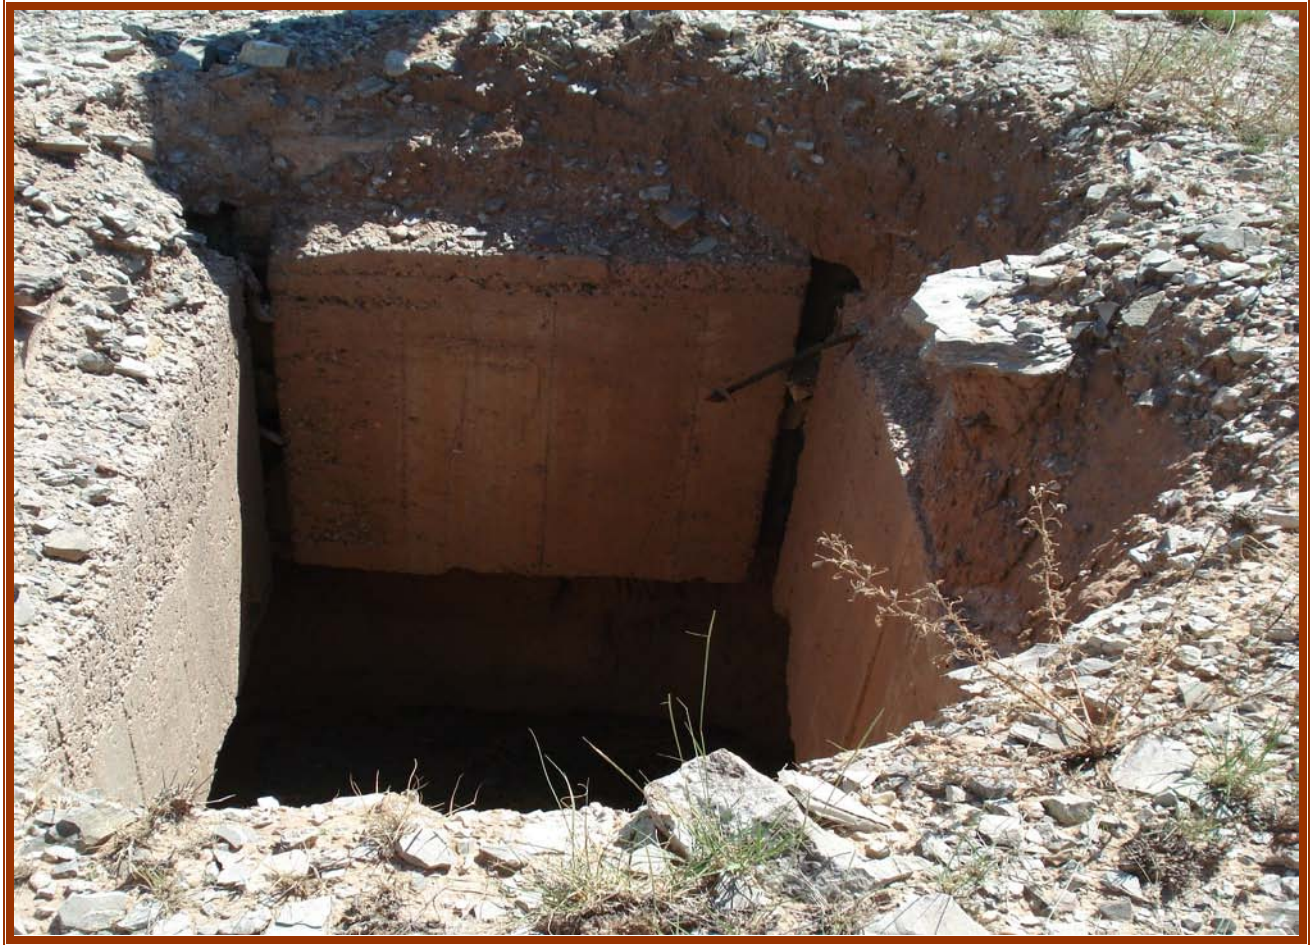
Signs of human activity were not recent. Vegetation is similar to undisturbed areas except waste piles that have less vegetation. Land use appears to be limited grazing for cattle but not recently. Previous reclamation of the shaft has subsided about nine feet. Total site area is approximately six acres. The nearest residence appears to be over 1-mile away in the southeast direction.

Mine Shaft Subsided Looking East

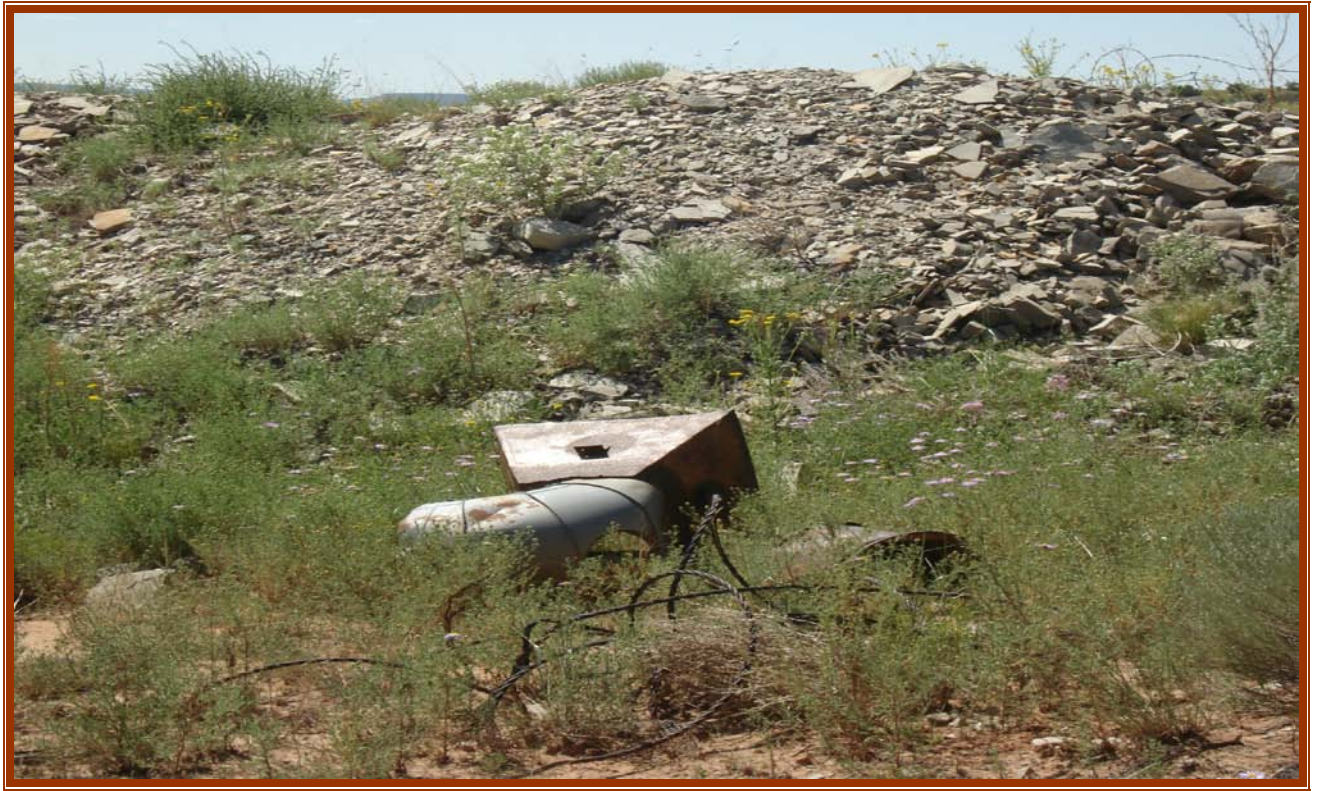
Mine Waste Metal Debris Looking South
